Tunnel Condition Report

S.1 Structural Condition Appraisal

Curtins Ref: B077572-CUR-ZZ-ZZ-RP-S-00001

Site Address: Cuerden Hall, Shady Ln, Bamber Bridge, Preston PR5 6AZ

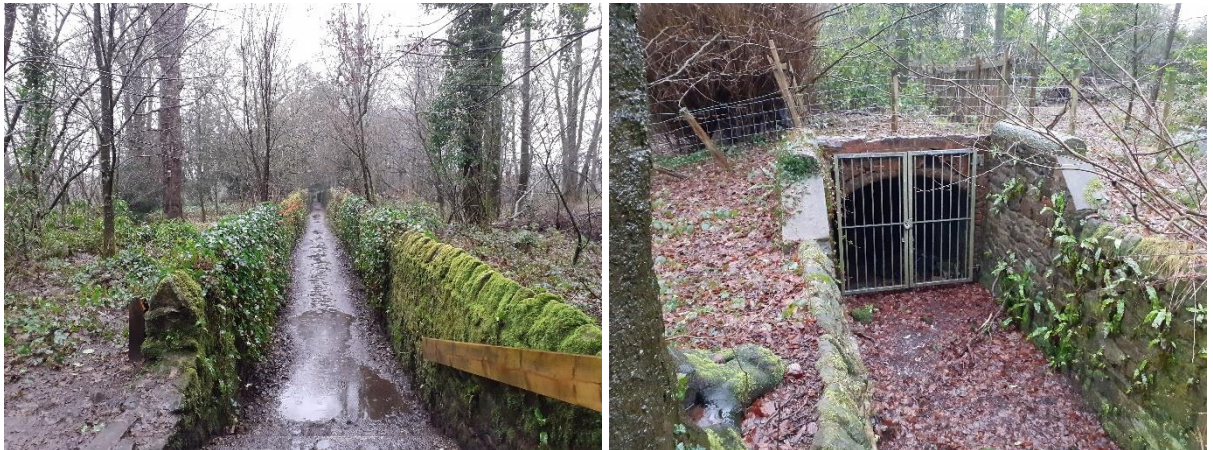
Figure 2: Pathway looking north (left) and south entrance of tunnel (right).

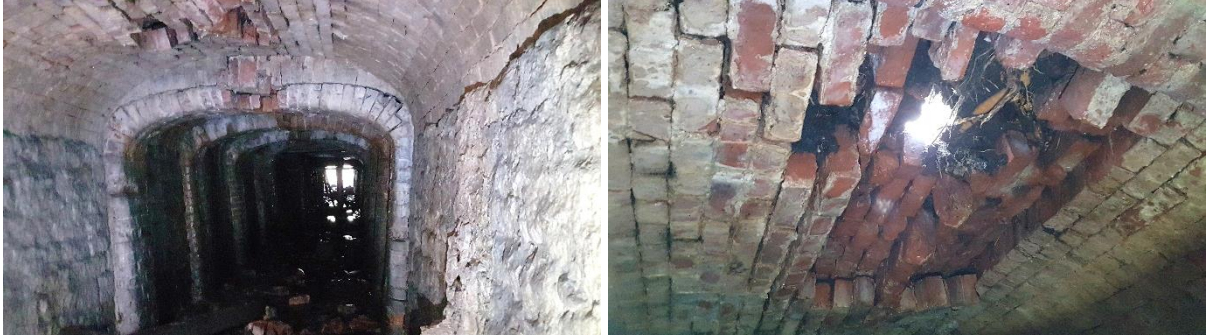
- 4.1 The geometry of the masonry barrel vault is severely deformed. The walls on either side of the passage are leaning out and the arching vault has flattened.
- 4.2 The north section of the tunnel is partly collapsed and a hole is visible above. There is clear skin separation in this area.

Figure 3: Deformed masonry barrel vault (left), and collapsed sections of vault with loose masonry units (right).

- 5.1 It appears that the section of tunnel was constructed in a cut and fill manner. The soil on either side of the tunnel masonry walls appears to have then deformed over time in response to the thrust from the arching structure.
- 5.2 This has resulted in the springing points of the arched masonry slowly being pushed further from each other and the span increasing significantly. The tunnel barrel vault and supporting arches have therefore formed a mechanism illustrated by the diagram below.

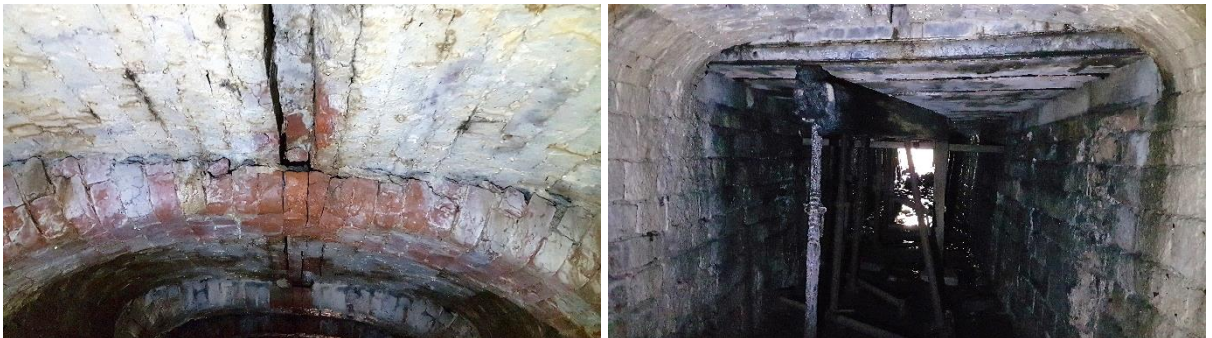
- 4.3 Loose masonry units were observed throughout particularly around the open joints at the crown.
- 4.4 The arches are unbonded to the masonry walls and the bricks at the crown have been cut to suit a deformed shape.

Figure 4: Arches unbonded and thinner at crown as if cut to fit deformed shape (left), and filler joist below road (right).

- 5.3 Multiple alterations / strengthening measures appear to have been attempted on the tunnel in the past. The arches are unbonded to the masonry walls and appear to be a later addition as the bricks at the crown have been cut to suit a deformed shape.

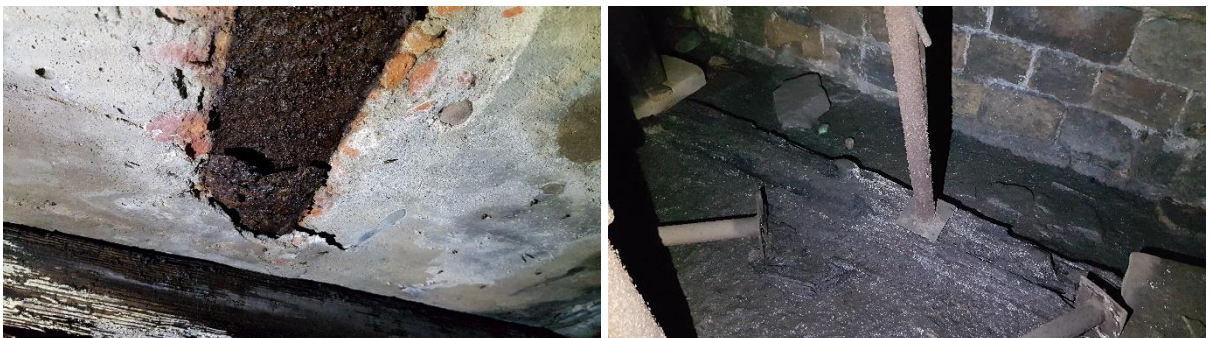
- 4.5 The top section of the tunnel directly below the road has been replaced by a filler-joist system possibly with a concrete relieving slab (investigations required to prove) resulting in the hump in the road above.
- 4.6 The below the road section, acrow props are corroding and the timber beams they were bearing on are decayed.

Figure 5: Concrete spalled and joists corroded (left), acrow props are corroding and the timber beams they were bearing on are decayed (right).

- 5.4 The top section of the tunnel directly below the road has been replaced by a filler-joist system with concrete relieving slab resulting in the hump in the road above. The underside of the joists are corroding and have been propped with acrow props between timber spreader beams.

- 5.5 The acrow props are corroding and the timber beams have decayed to the point where these measures are no longer touching the filler-joist floor above rendering them ineffective.

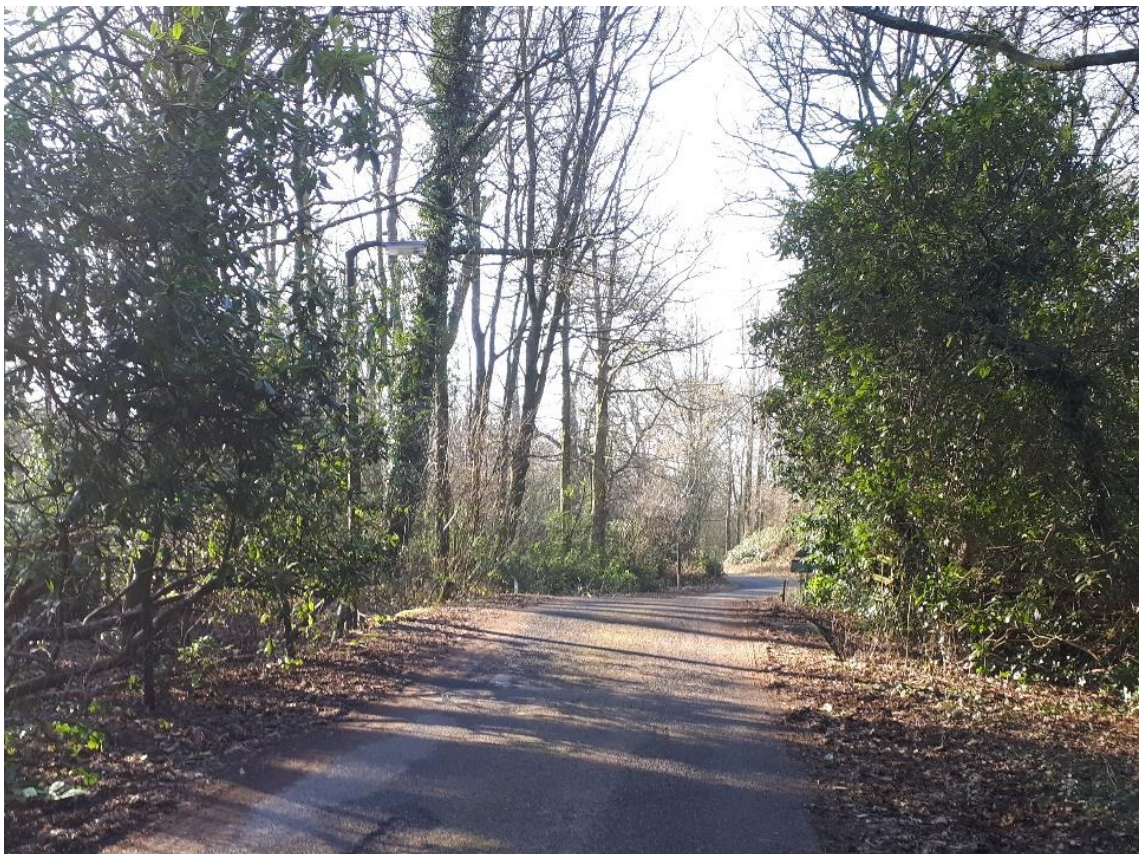
4.7 No deformation or structural defects were noted in carriageway finishes above tunnel.

Figure 7: View of the hump in the road above tunnel looking west.

- 5.6 The carriageway crossing over the bridge does not show signs of distress/ deformation. In this respect, engineering judgement suggests that the bridge is suitable for light vehicles i.e cars only.

- 6.4 We cannot confirm to what extent these multiple measures are still effective, and consequently the residual strength of this tunnel, so we recommend that the bridge over the tunnel should be closed to vehicles in excess of 3 tonnes until repairs are undertaken.

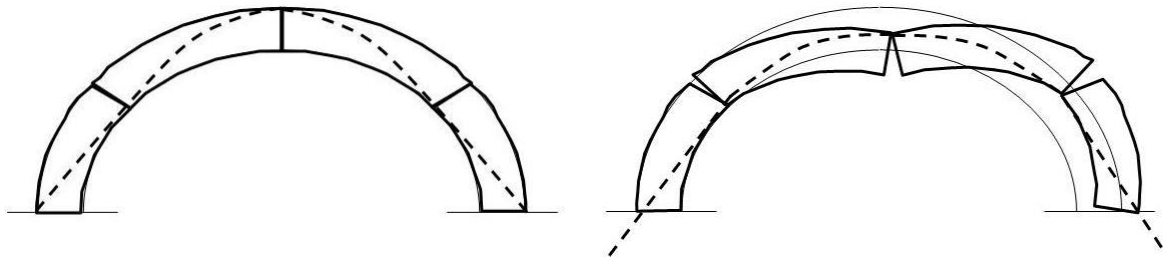
Figure 8: Thrust line through undeformed barrel vault (left), collapse mechanism created in deformed barrel vault (right)

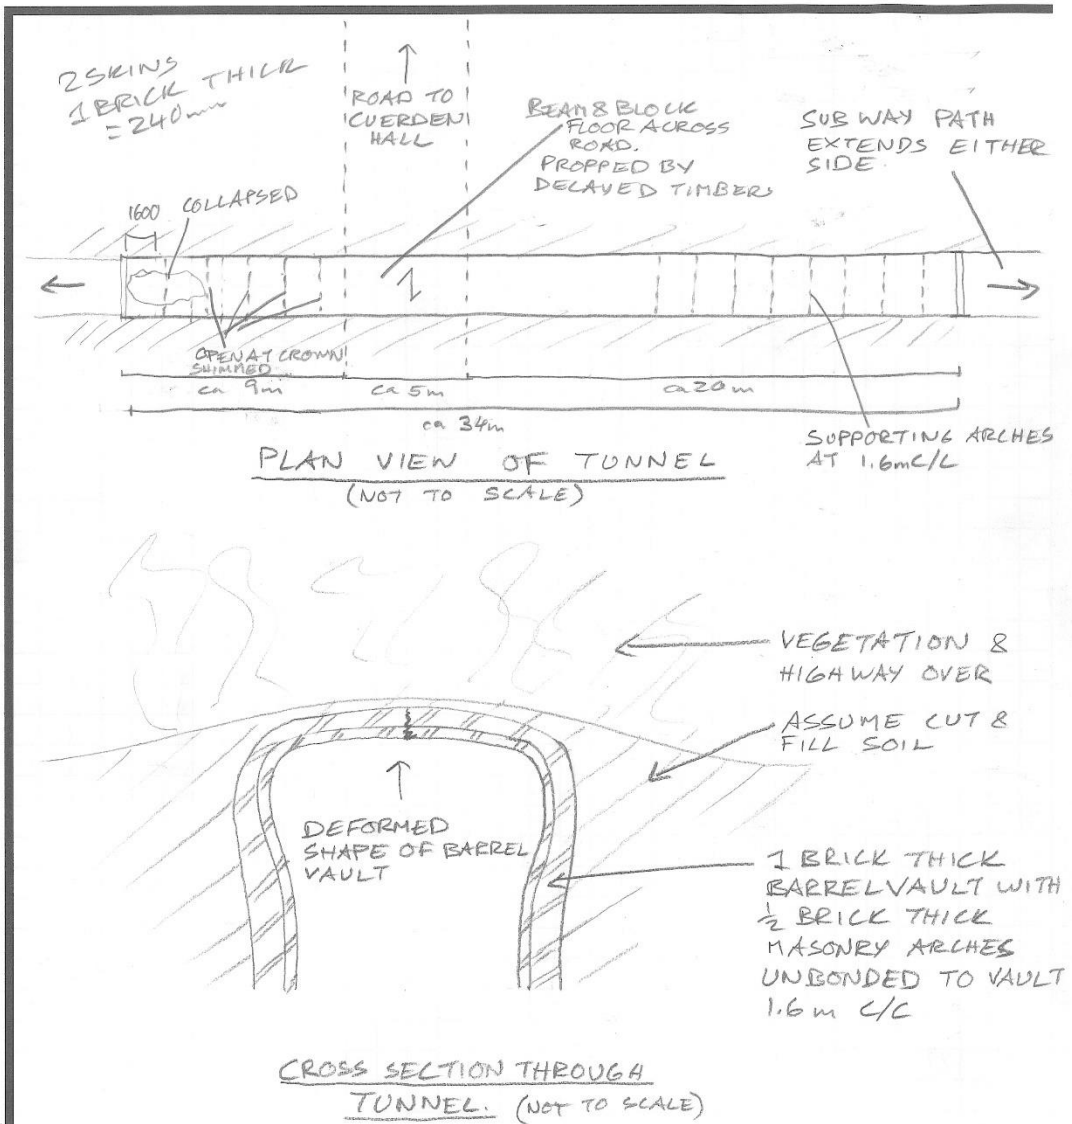
- THIS TUNNEL IS IN A DANGEROUS CONDITION
- THE BARREL VAULT IS PARTIALLY COLLAPSED
- SOME OF THE ARCHES HAVE COLLAPSED, THE REMAINING ARCHES ARE UNBONDED.
- APPEARS TO BE A CUT & FILL PASSAGE WHERE THE SOIL ON EITHER SIDE WAS NOT COMPACTED/ STRONG ENOUGH TO RETAIN THE THRUST FROM THE ARCHING BARREL VAULT. THIS HAS LED TO ITS ARTICULATION TO THE POINT OF SUBSEQUENT COLLAPSE
- TOP DOWN INVESTIGATION REQUIRED OF REINFORCEMENT BELOW ROAD.
- CAREFUL DEMOLITION & EITHER REBUILD OR INFILL REQ.
